DELAWARE RIVER BASIN  
TRIBUTARY TO POPHANDUSING BROOK,  
WARREN COUNTY  
NEW JERSEY

**N.J. NO NAME DAM  
NO. 55  
NJ 00815**

**PHASE 1 INSPECTION REPORT  
NATIONAL DAM SAFETY PROGRAM**

**AUGUST 1981**

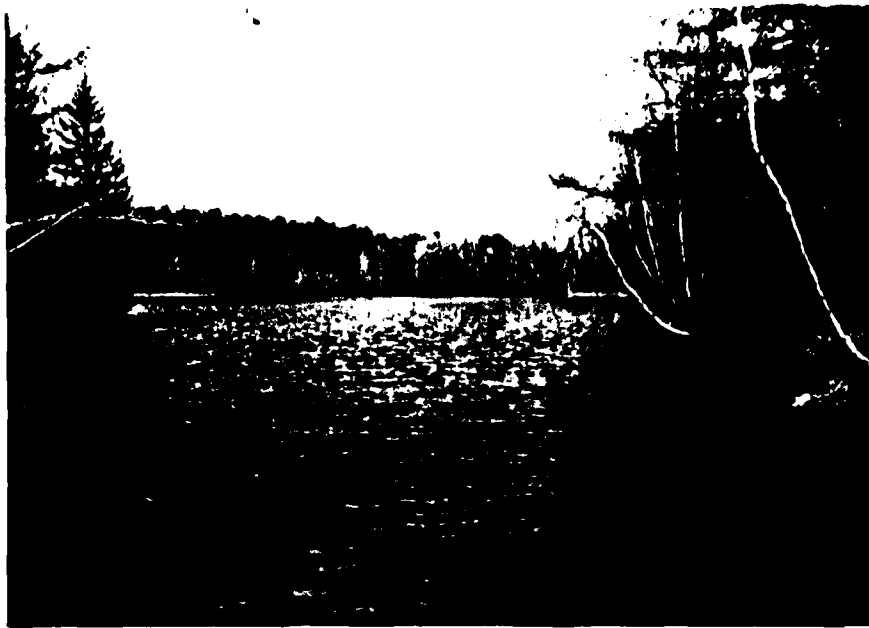
View looking southwest across reservoir from right dam abutment.
